Illicit Discharge Detection and Elimination (IDDE) Plan

TOWN OF WINDHAM, NEW HAMPSHIRE

Permit Year 7

EPA NPDES Permit Number NHR041000

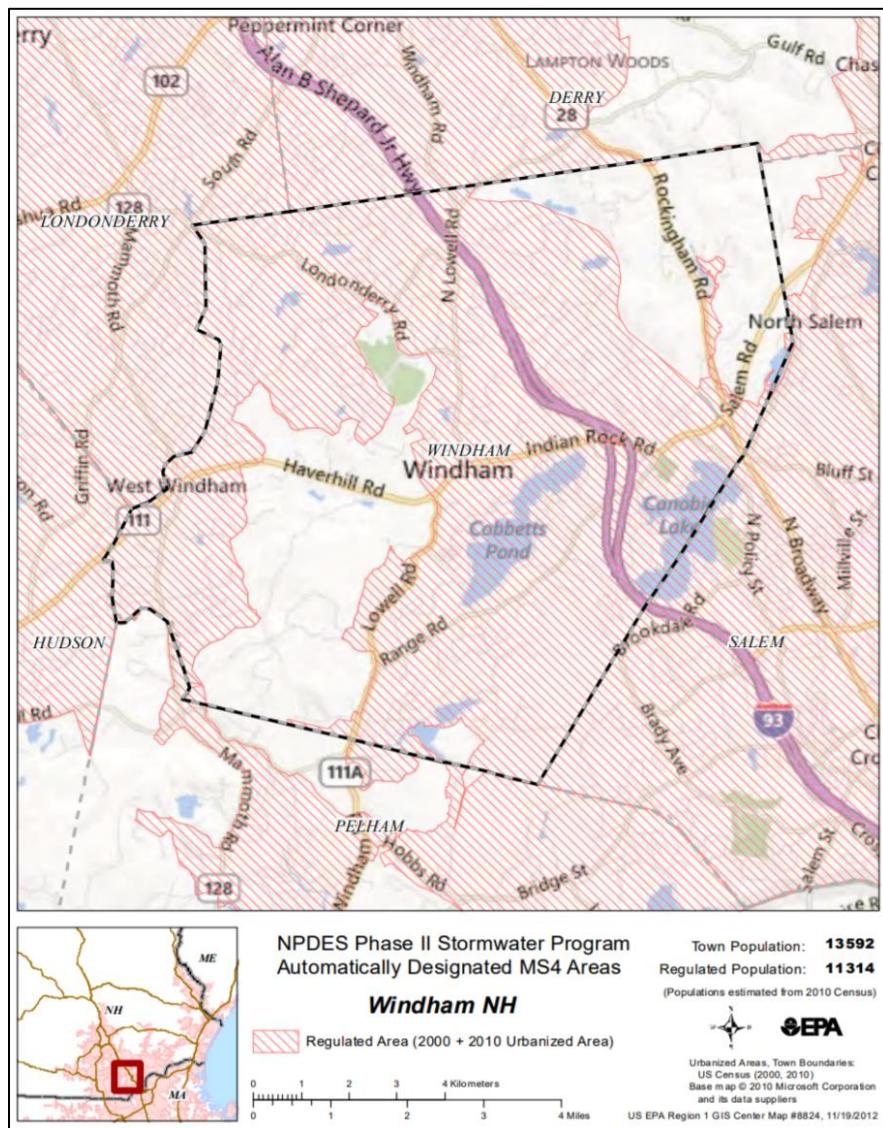
Figure 1.4.A : Windham, NH | NPDES Phase II Stormwater Program Automatically Designated MS4 Areas
<https://www3.epa.gov/region1/npdes/stormwater/nh/ram/Windham.pdf>

The MS4 Permit requires towns to implement the IDDE program within the Urbanized Area as depicted in the Figure below:

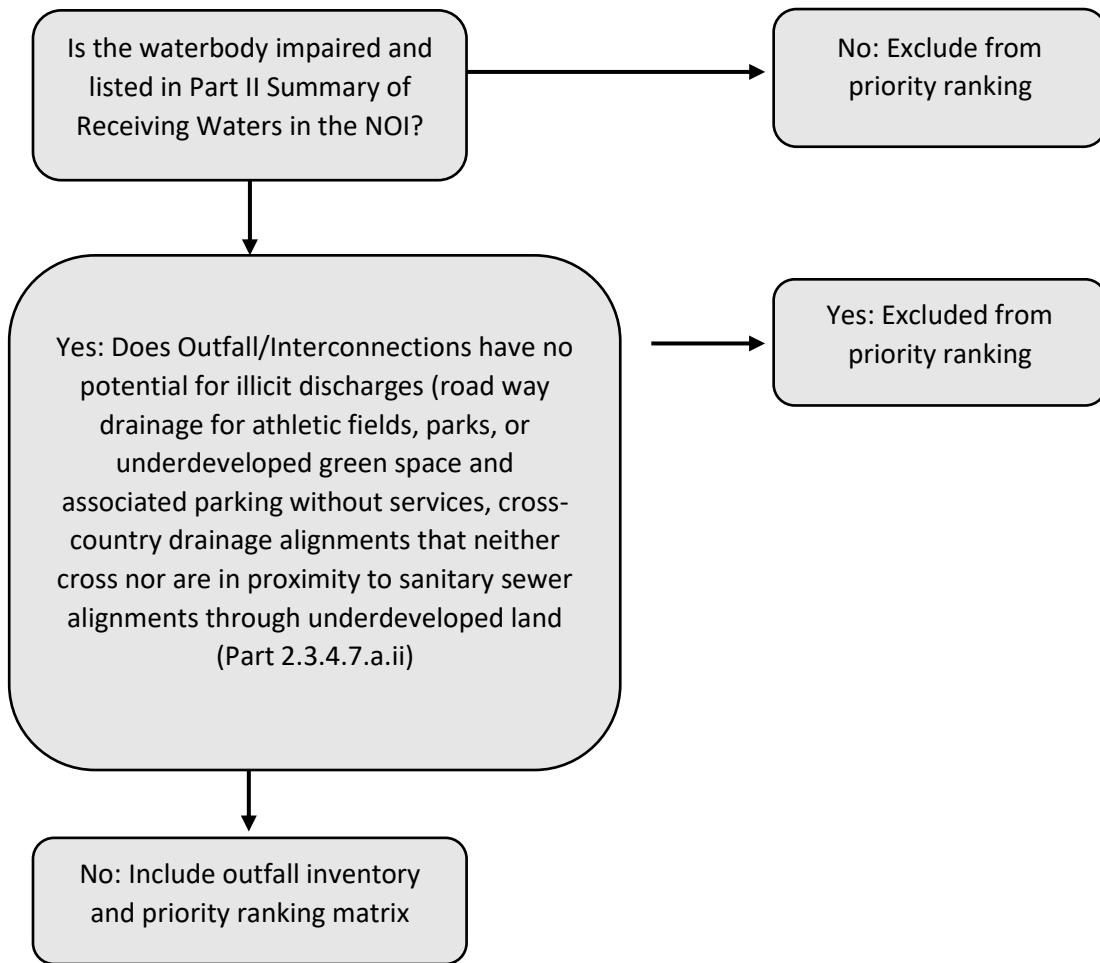
FIGURE 1
Initial Outfall Prioritization Flowchart

*see **Appendix D** for the outfall inventory and priority ranking matrix (2019)

Outfalls are ranked into the above priority categories (except for excluded outfalls, which may be excluded from the IDDE program) based on the following characteristics of the defined initial catchment areas, or where information is available.

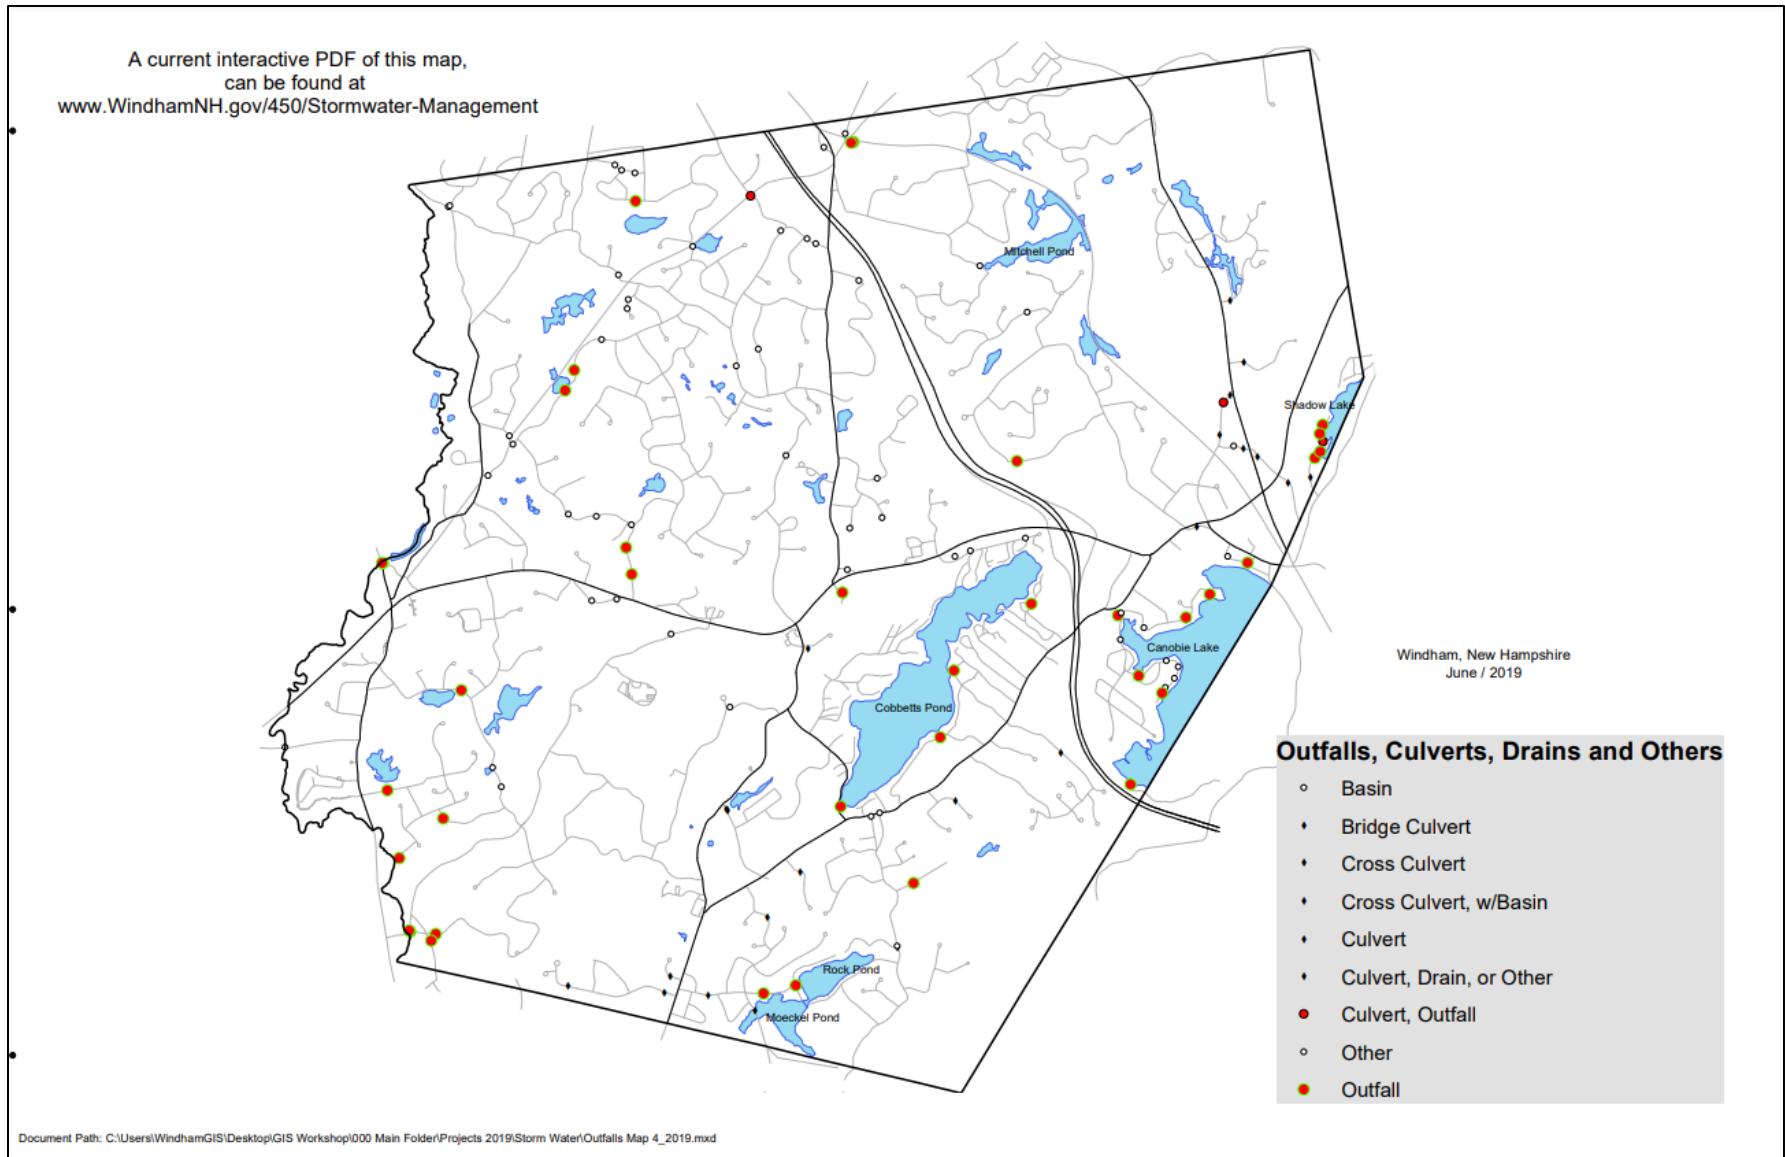
Outfall and Culverts Map (2019)

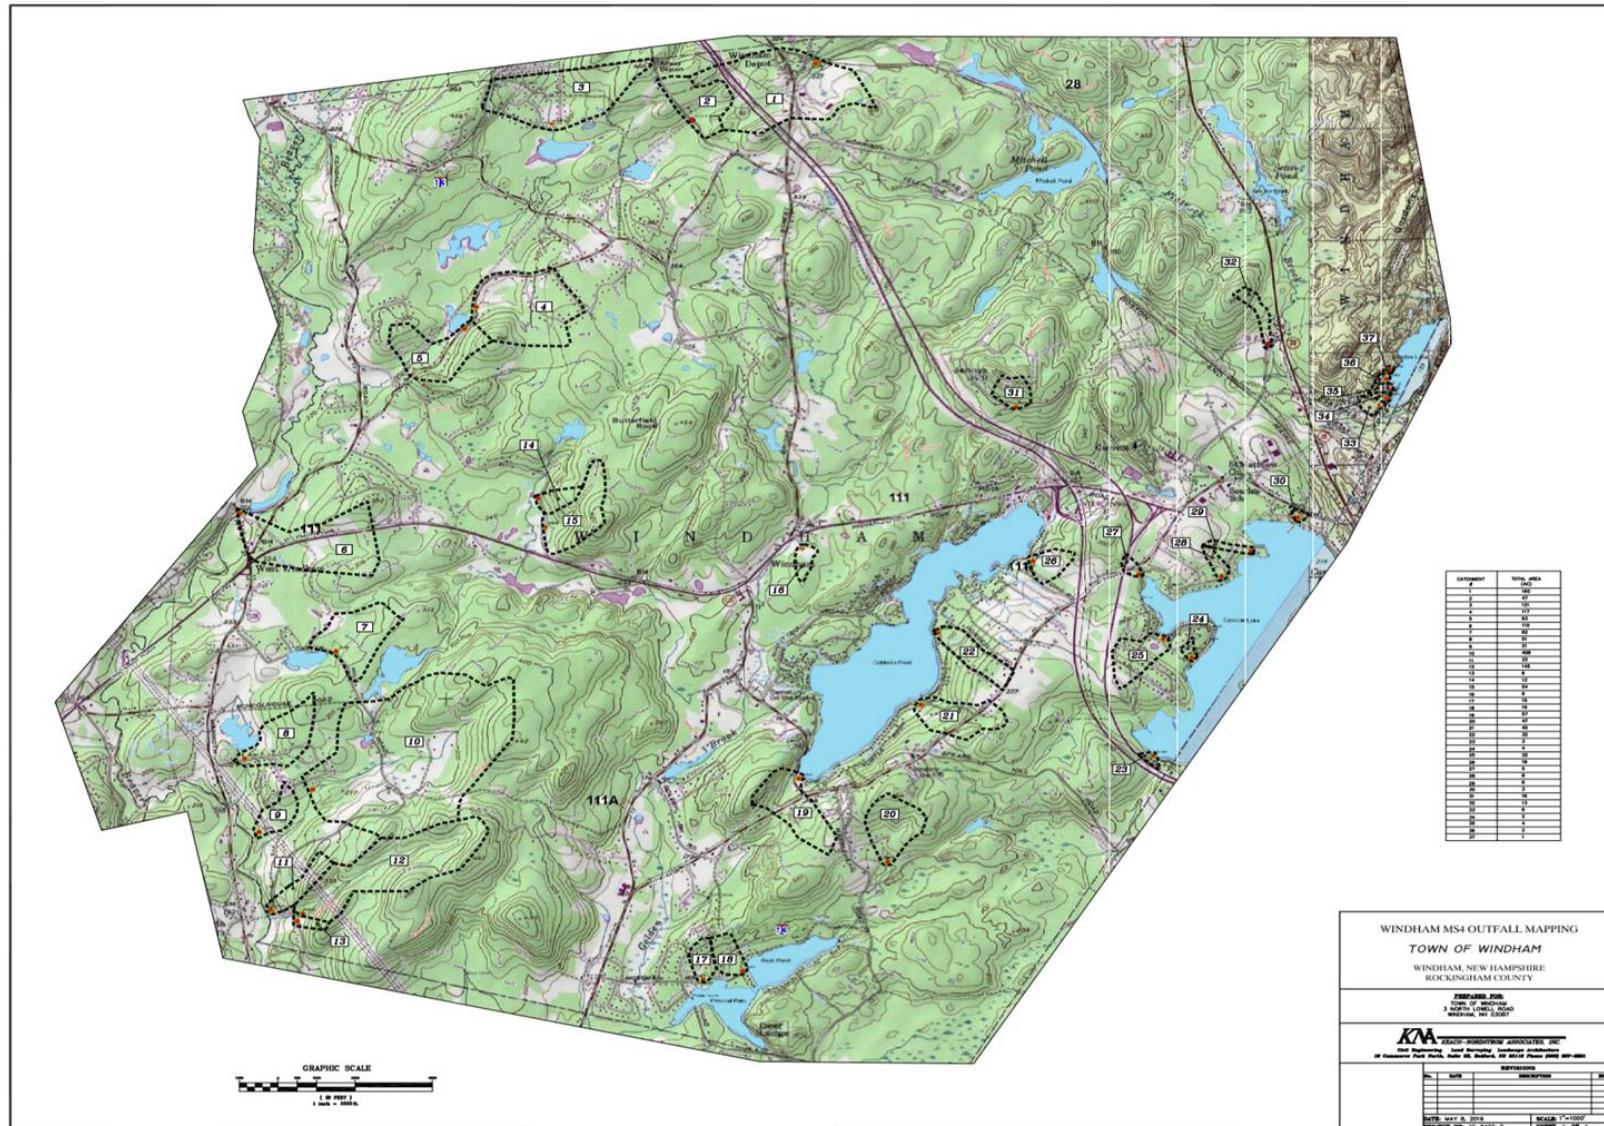
Map of Initial Catchment Delineation (2019)

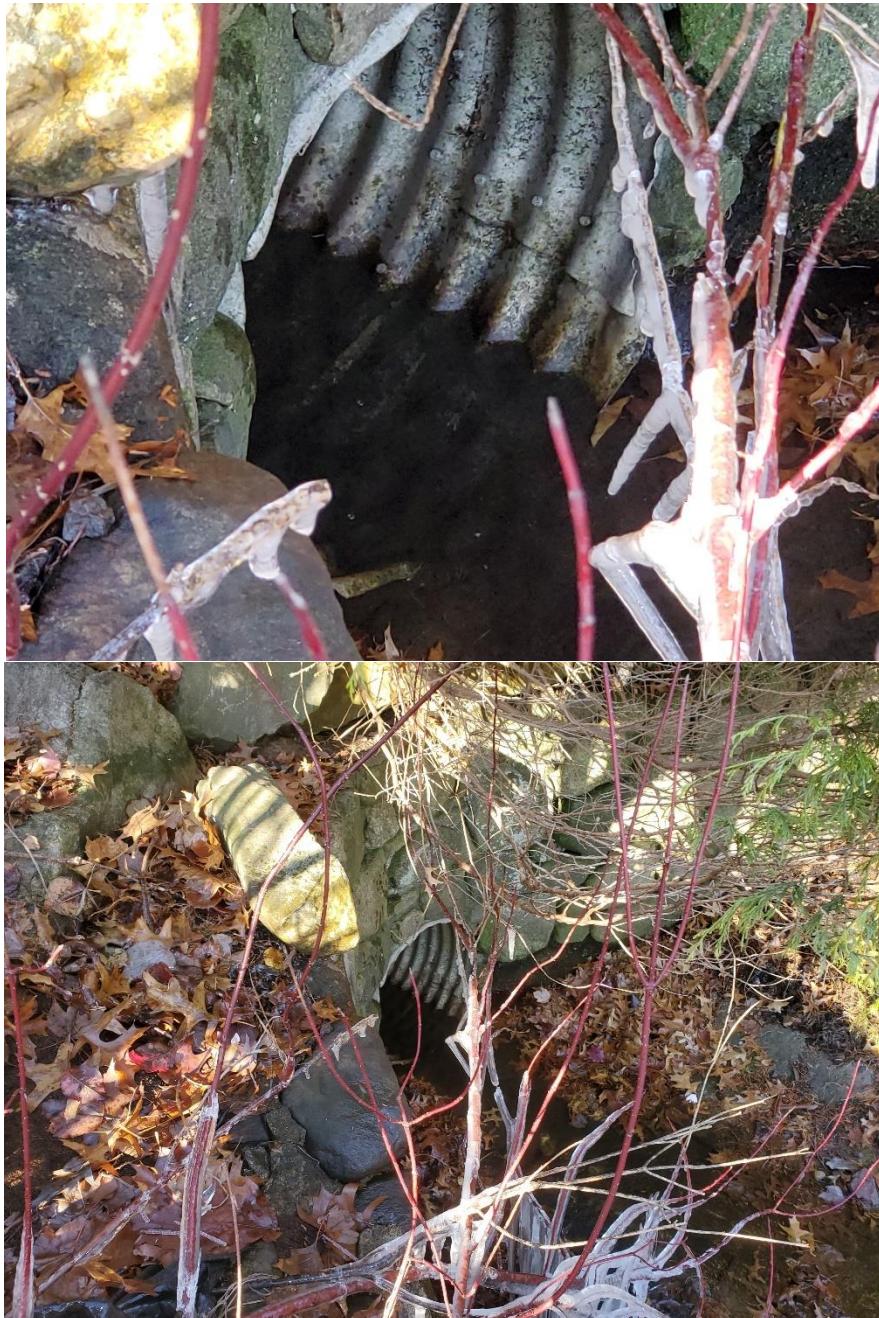
Photos 1 - 2: Outfall 28 on 12/8/2023

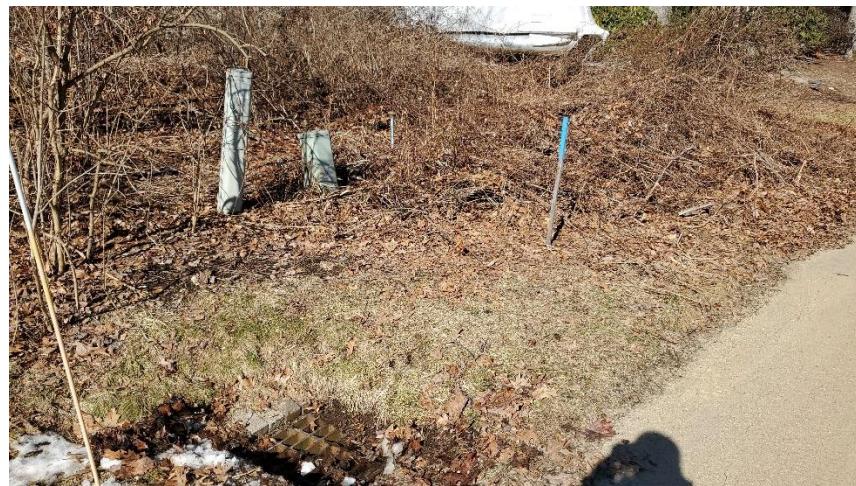
Photo 3: CB 2360 where Field Inlet_21 is located

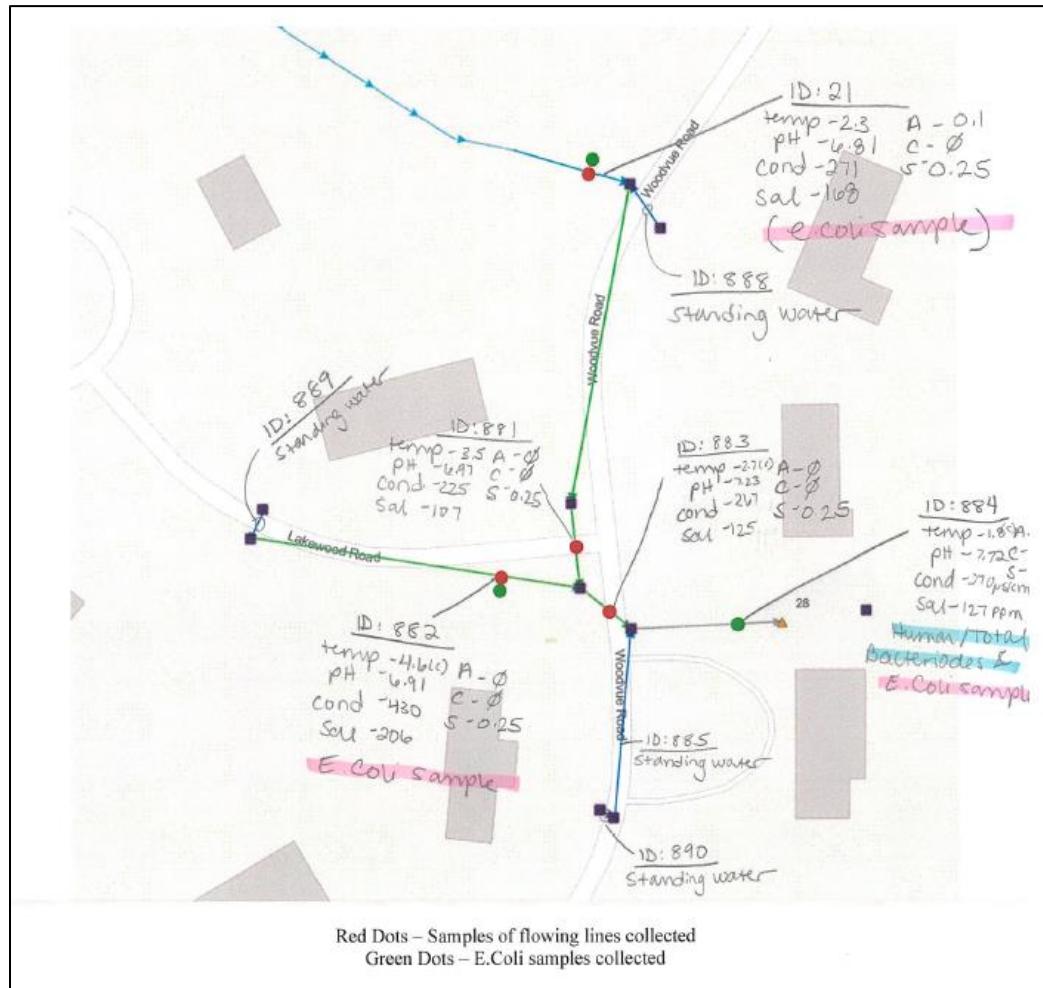
Attachment 1: Locations where lab samples/field analyses were performed during investigation

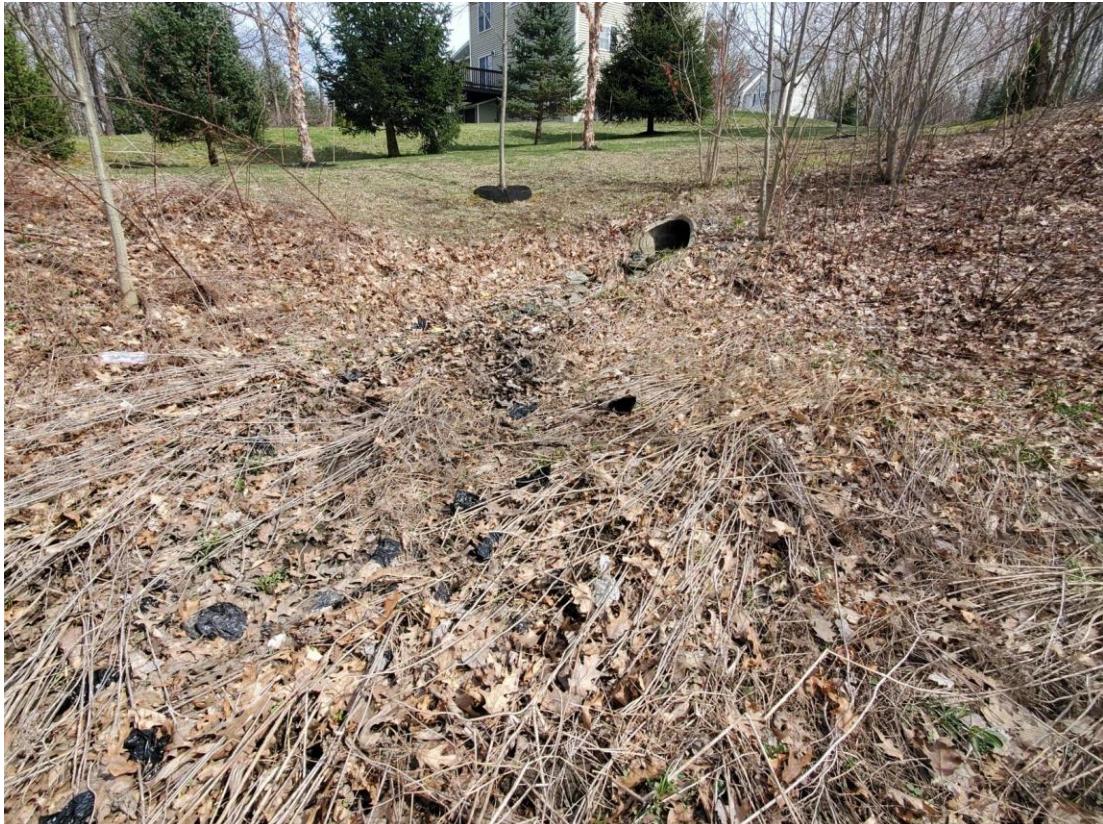
Photo 1 – Zoomed out photo of Pipe 1748 discharge point into Mitchell Pond Rd_DB

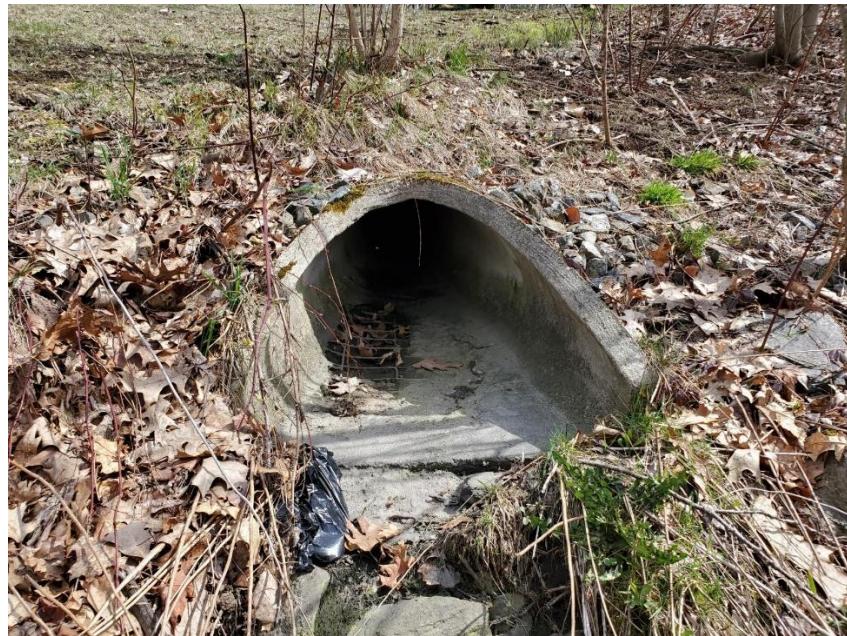
Photo 2 – Discharge point of Pipe 1748

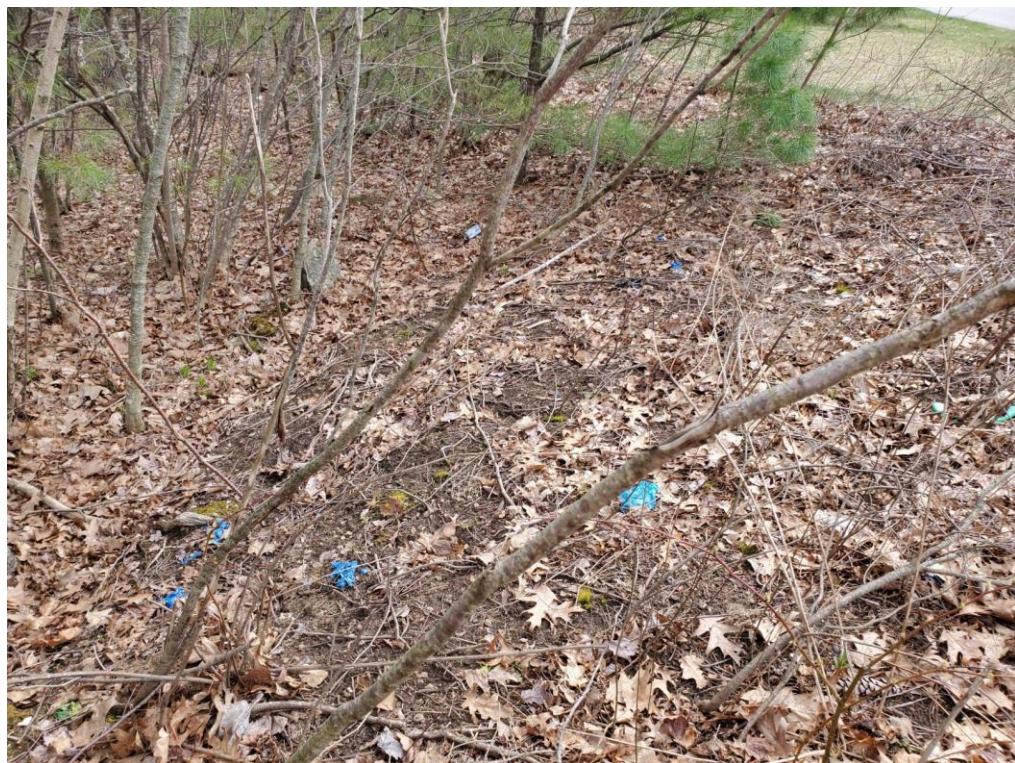
Photo 6 – Bags observed in Parcel 3-A-512

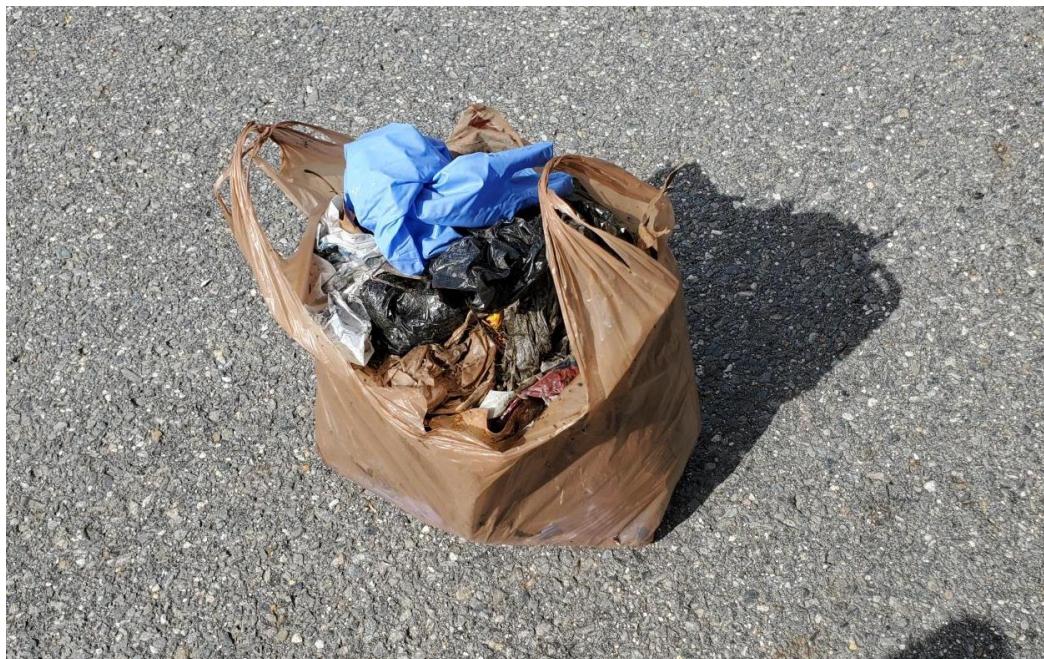
Photo 7 – Pet waste bags collected on 4/19/2024

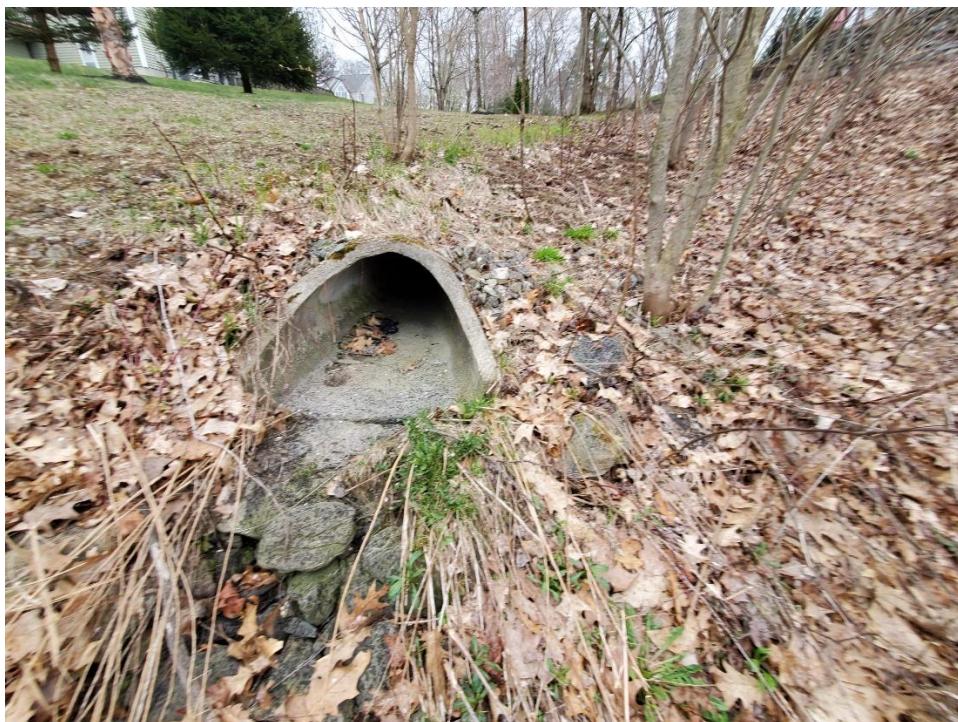
Photo 6– Outlet of Pipe 1748 on 4/24/2024 when an additional 15 bags were retrieved

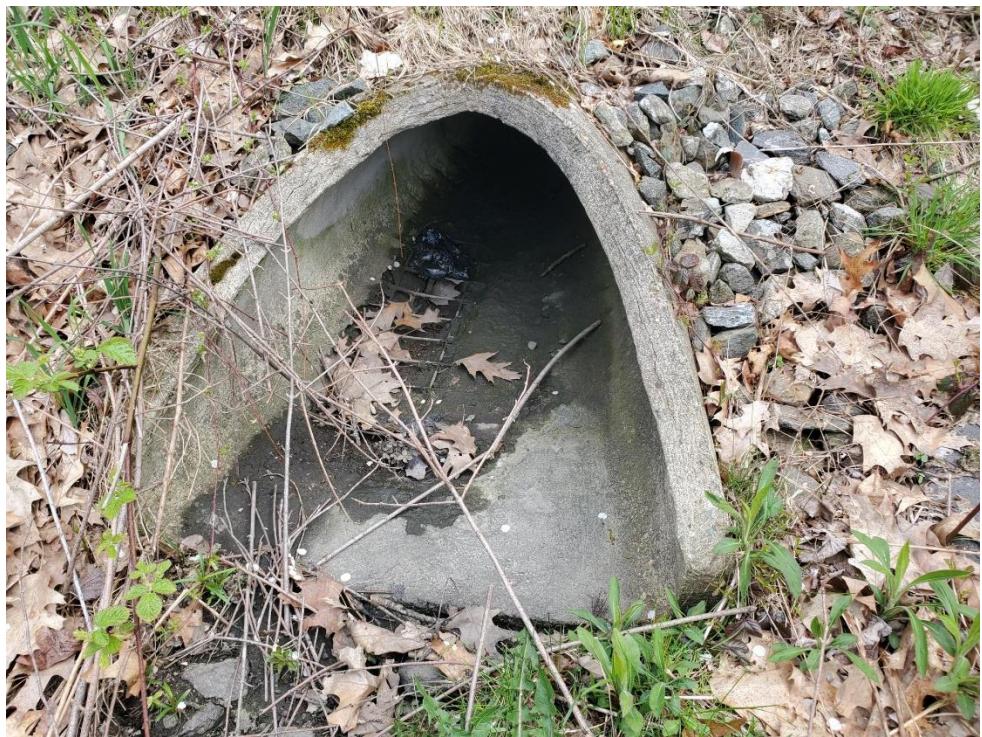
Photo 7 – Pipe 1748 on 5/6/2024

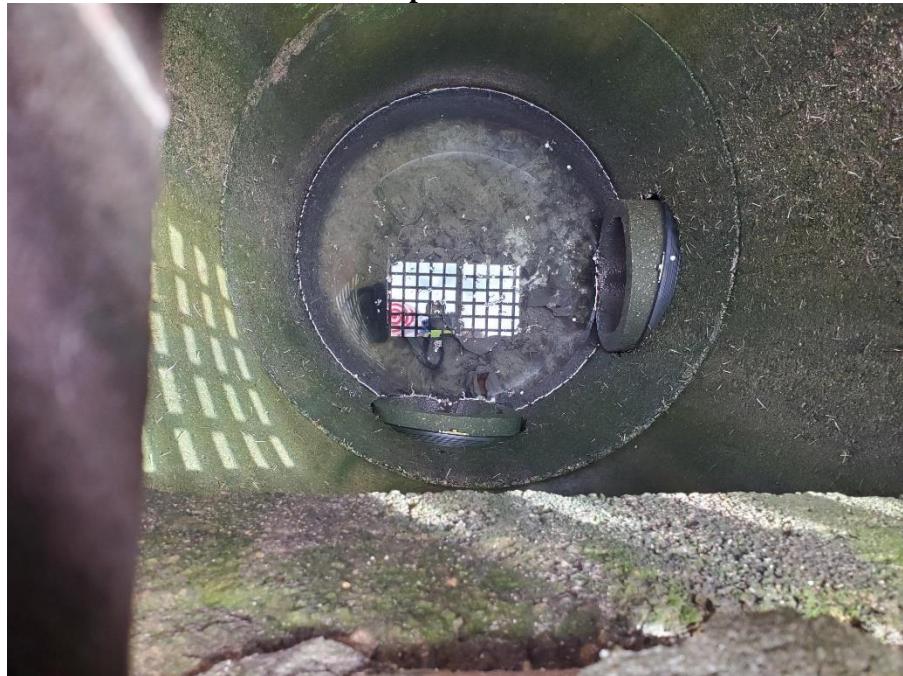
Photo 8 – Pet waste bags observed in sump of catch basin 1617 on 5/6/2024

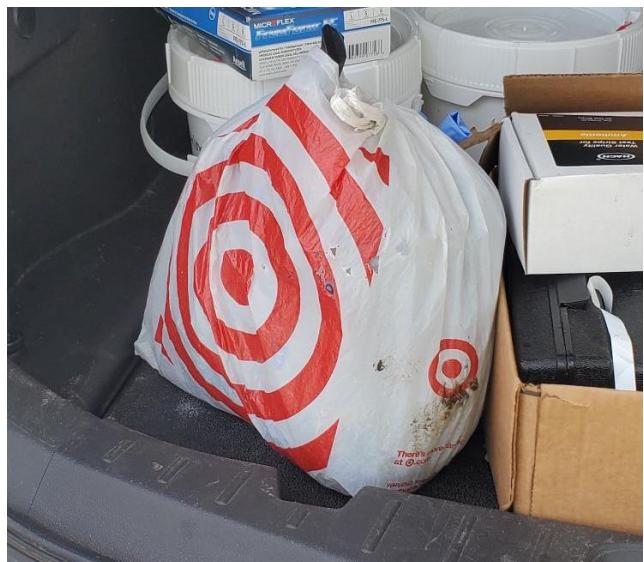
Photo 9 – Additional bags collected during site visit 5/6/2024

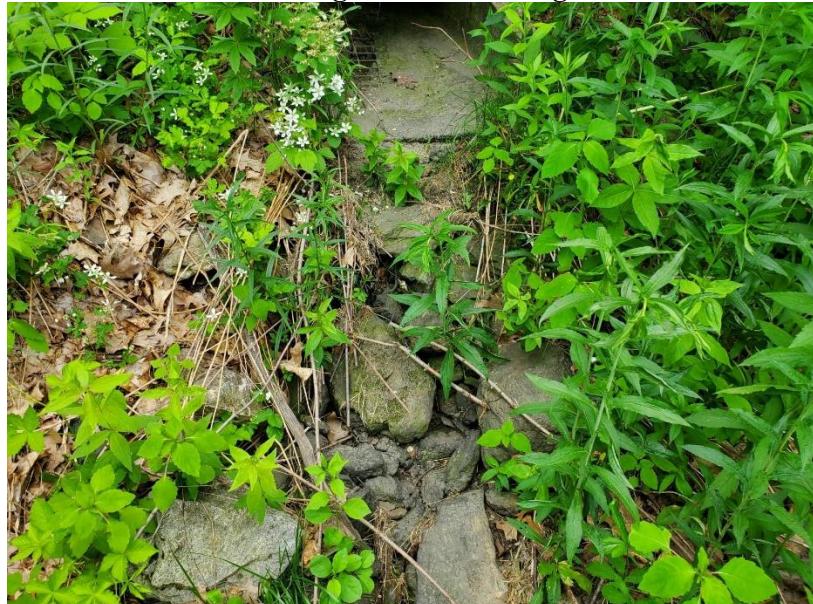
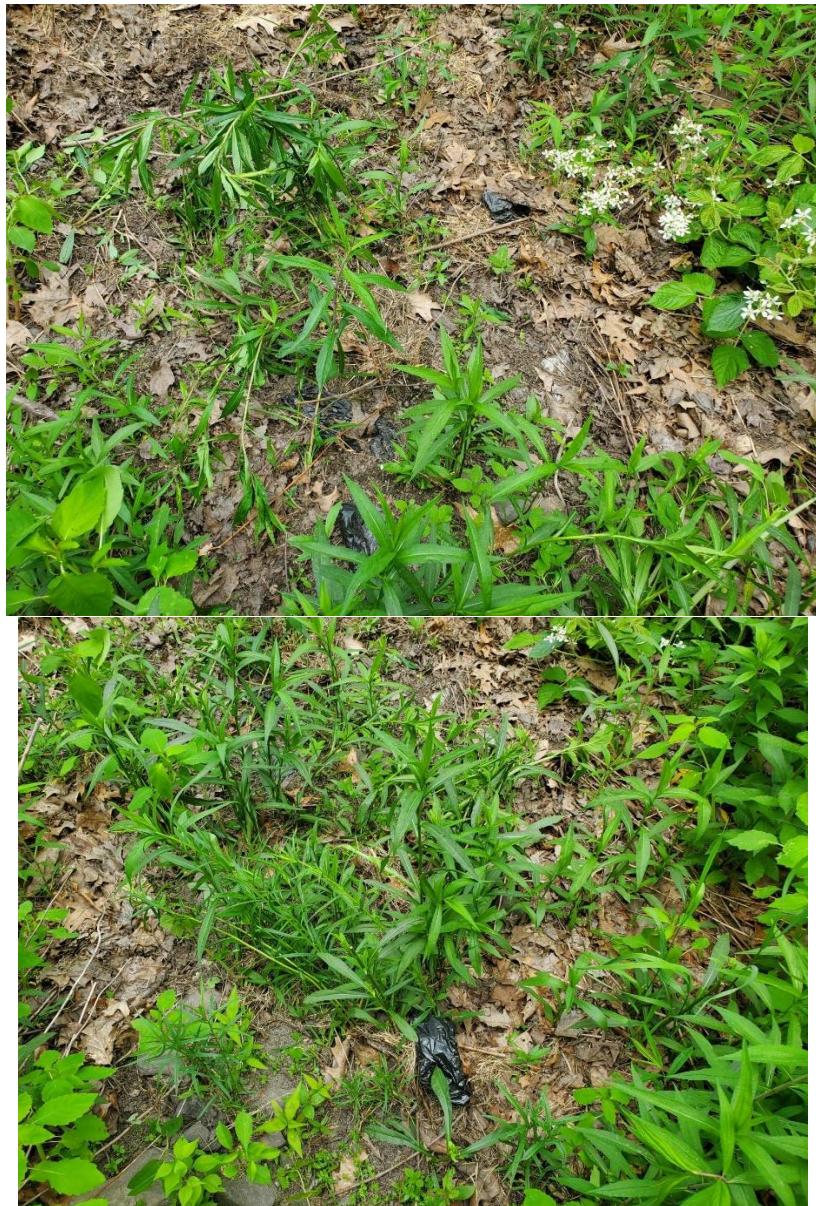
Photos 10-12 – Photos taken of end of Pipe 1748 on 06.05.2024 where an additional 12 bags were located

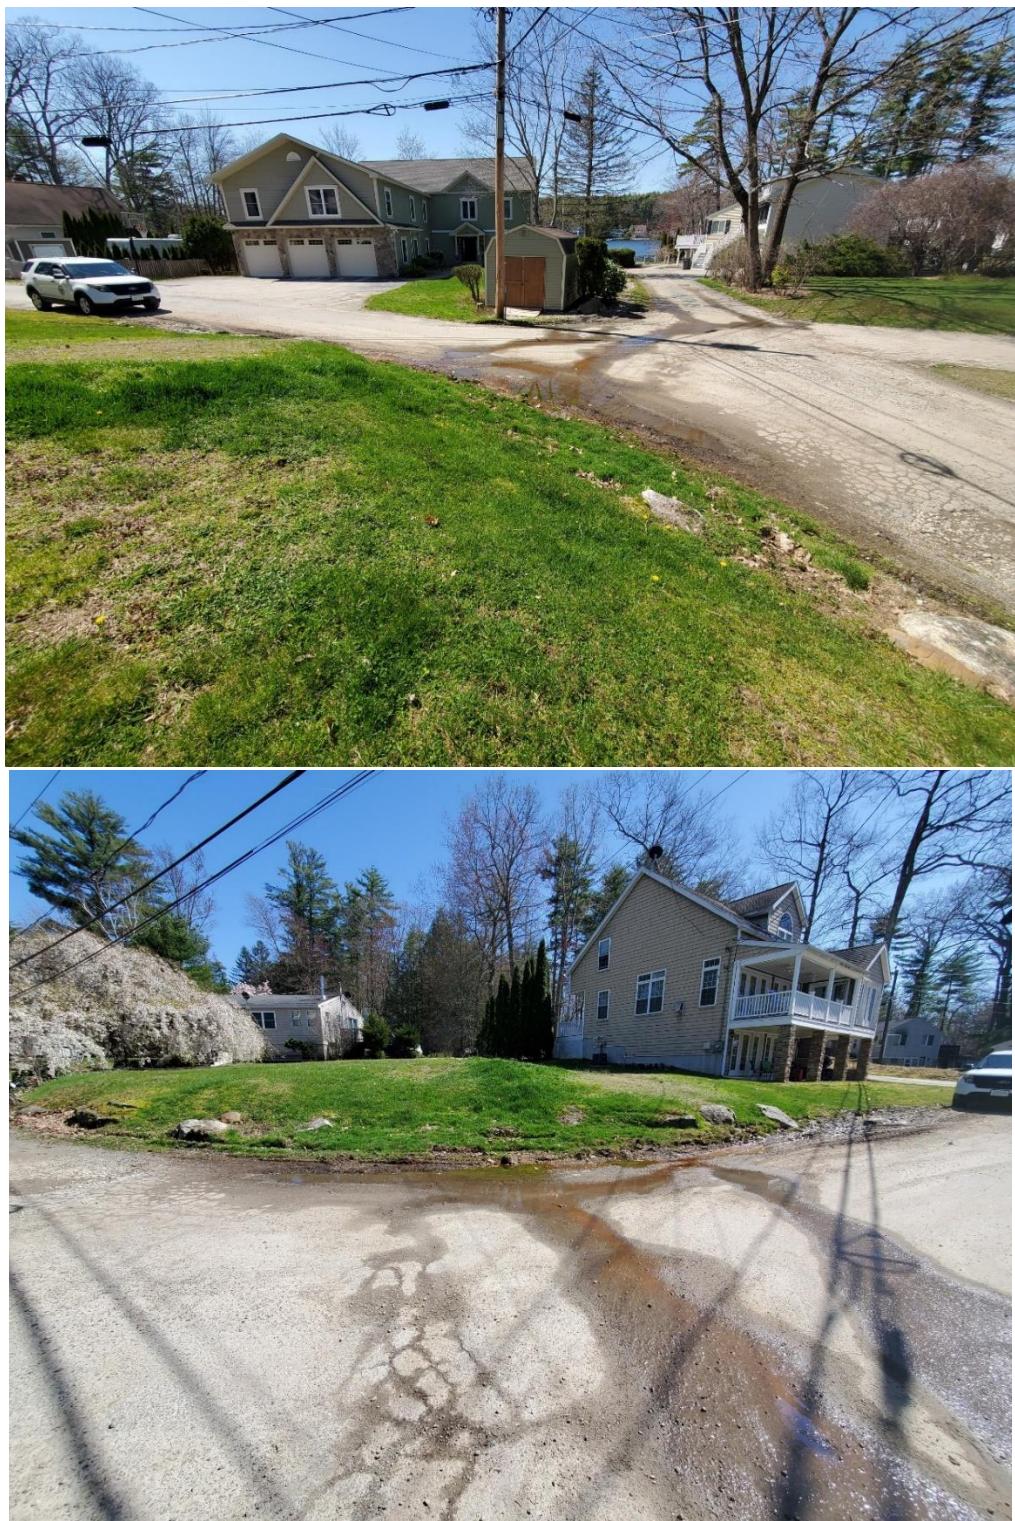
Pictures 1 and 2 – Runoff from suspected failed septic system

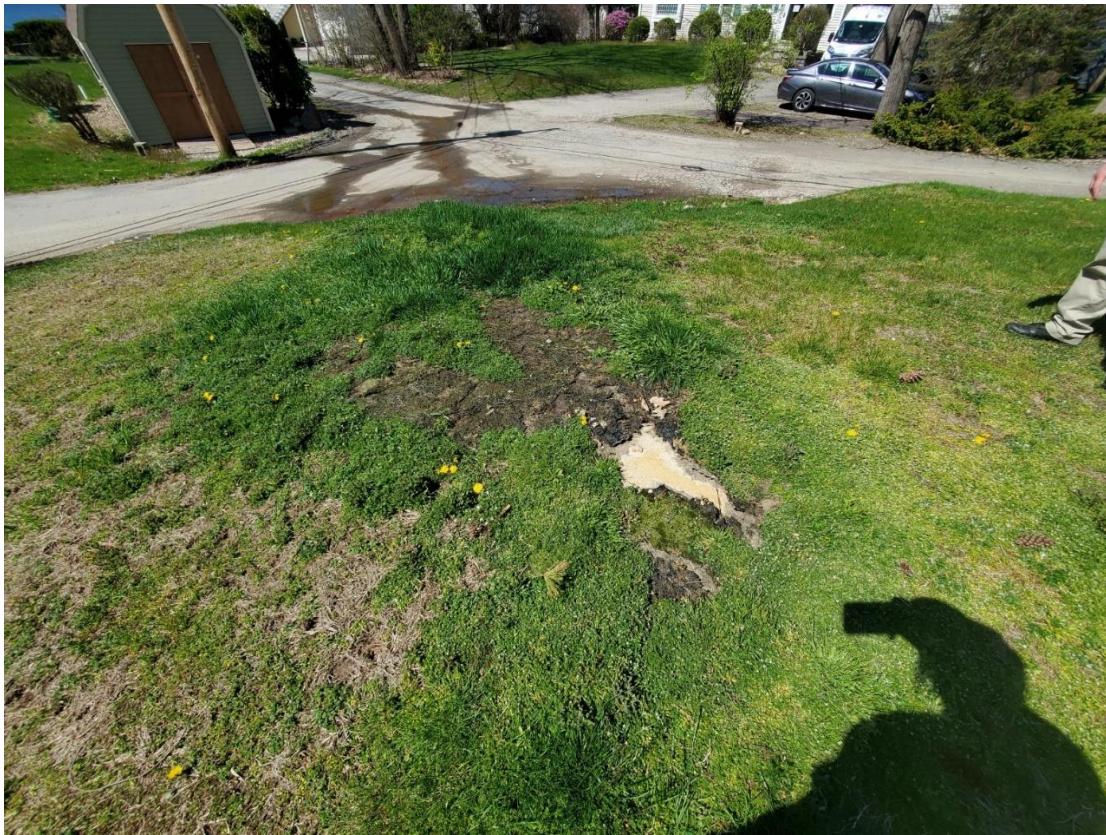
Picture 3 –system location

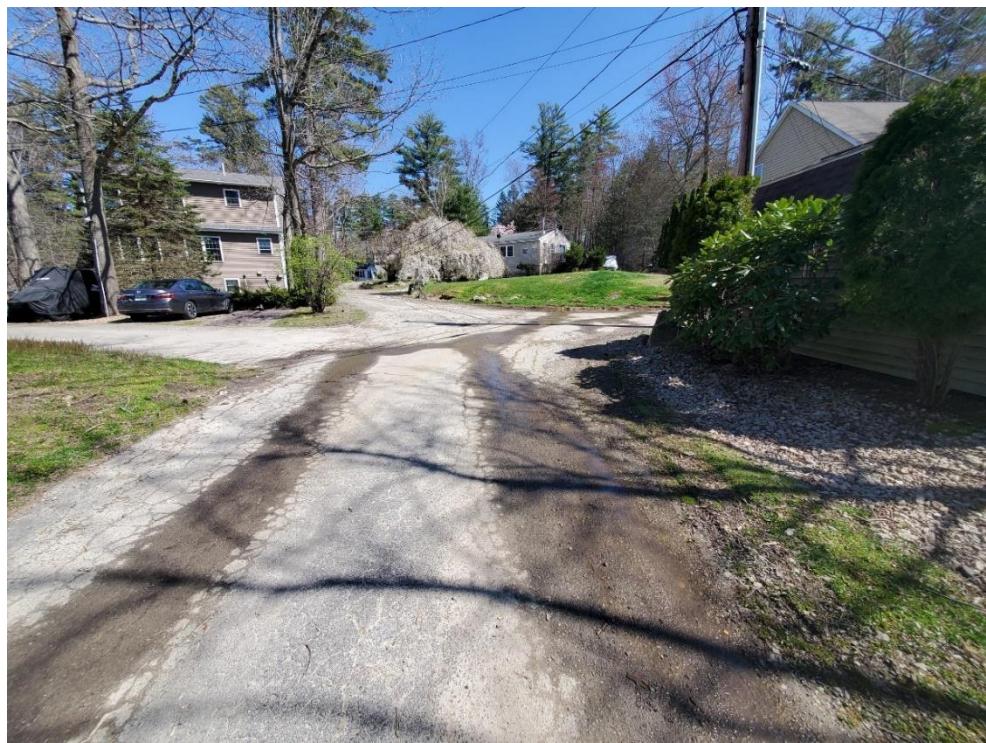
Picture 4 – Visible runoff on ground (facing septic system)

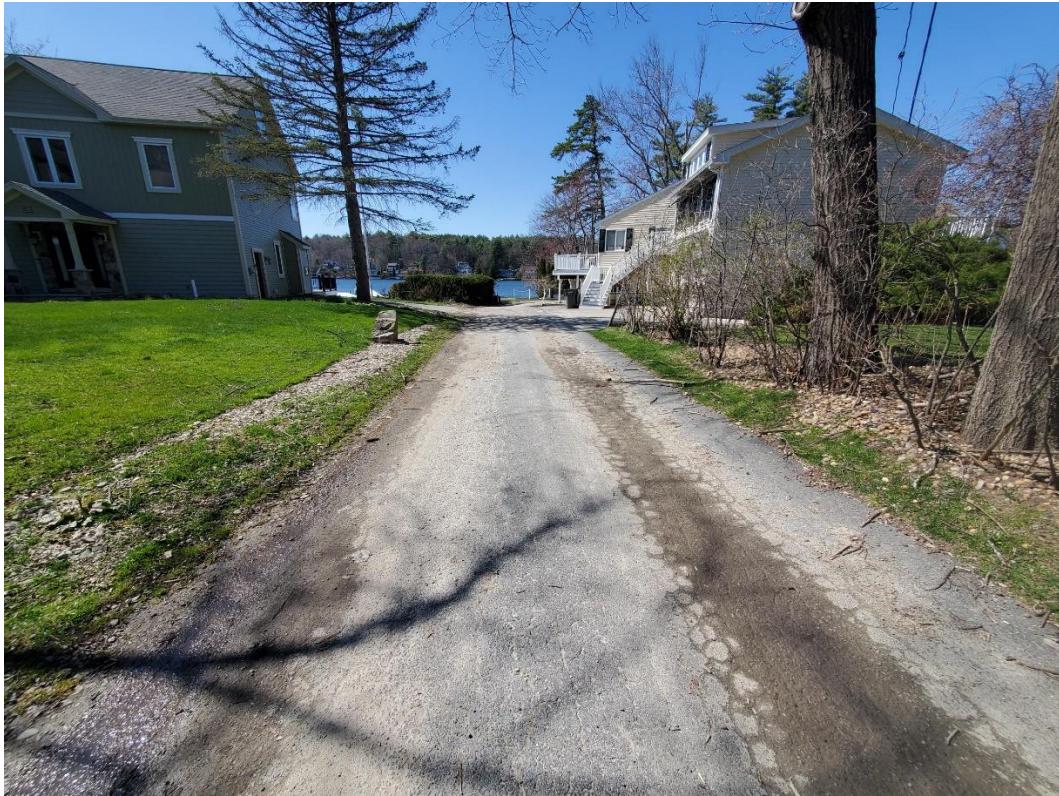
Picture 5 – Facing away from septic system toward Cobbett's Pond to show proximity to waterbody

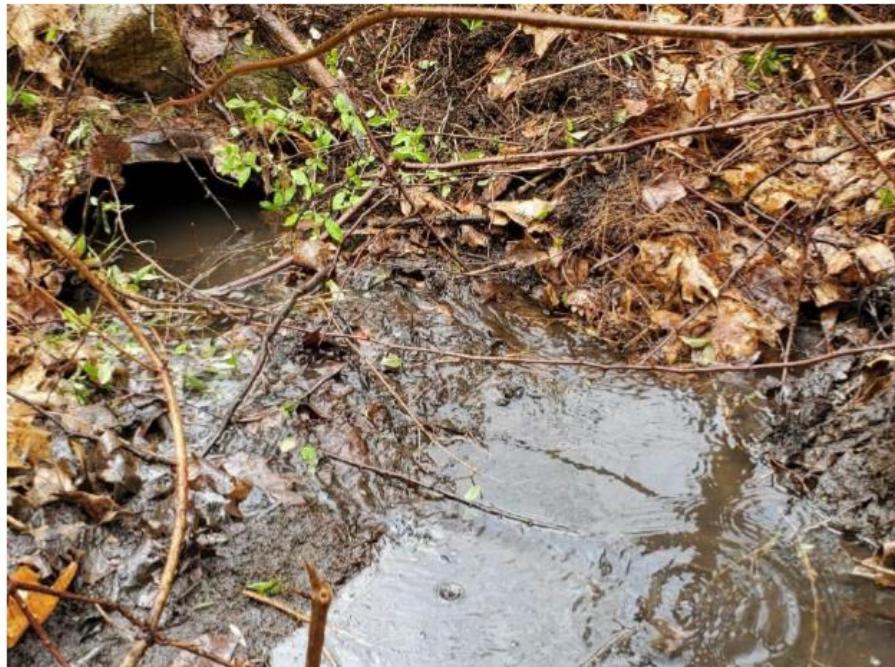
Picture 1 – Outfall 184 on 4/30/2024

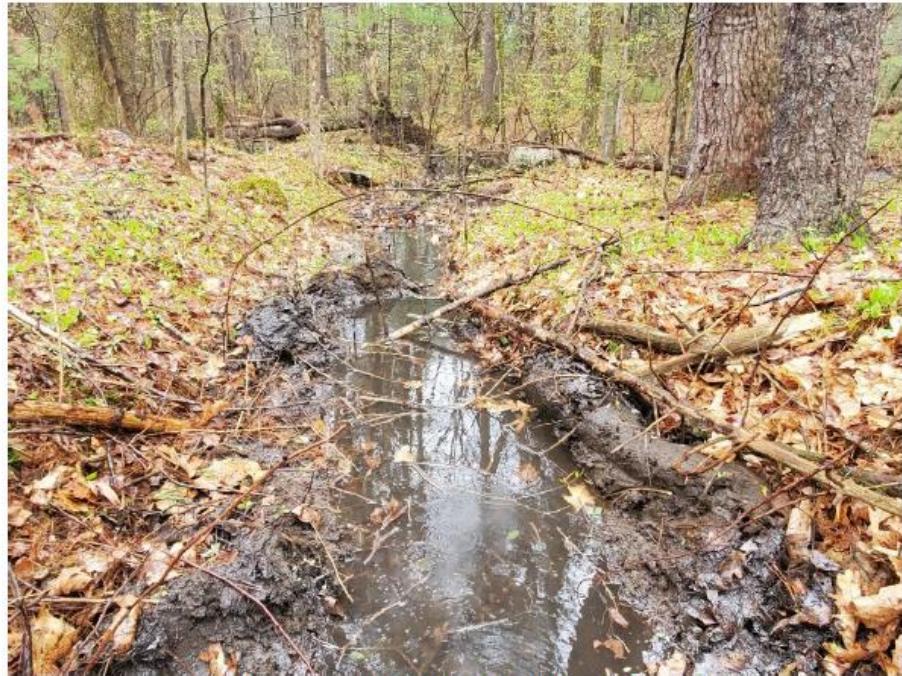
Picture 2 – Swale leaving outfall on 4/30/2024

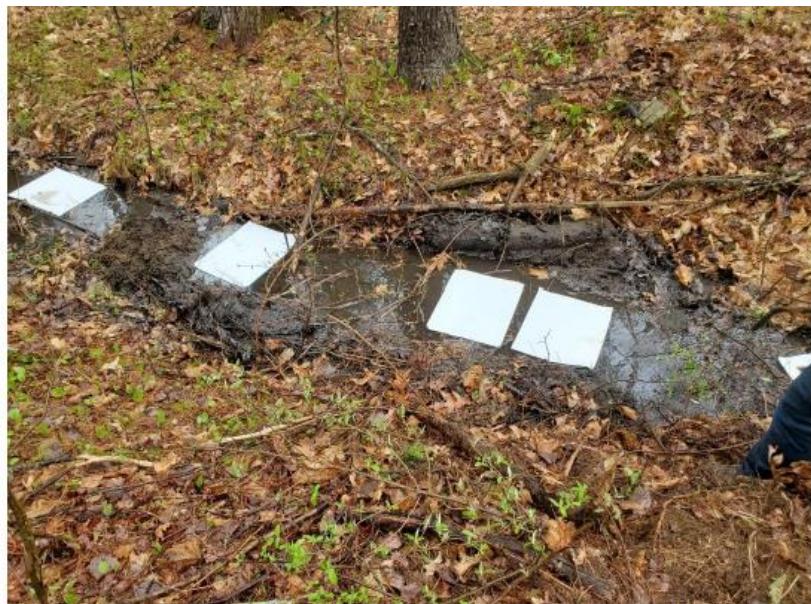
Picture 3 – Oil absorbing pads placed in flow exiting outfall (4/30/2024)

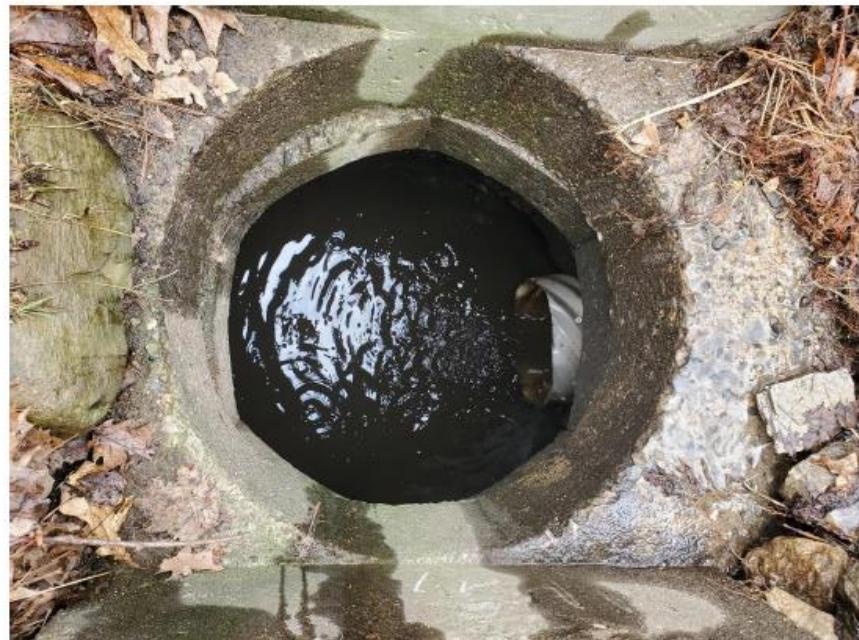
Picture 4 – CB 680 on 4/30/2024

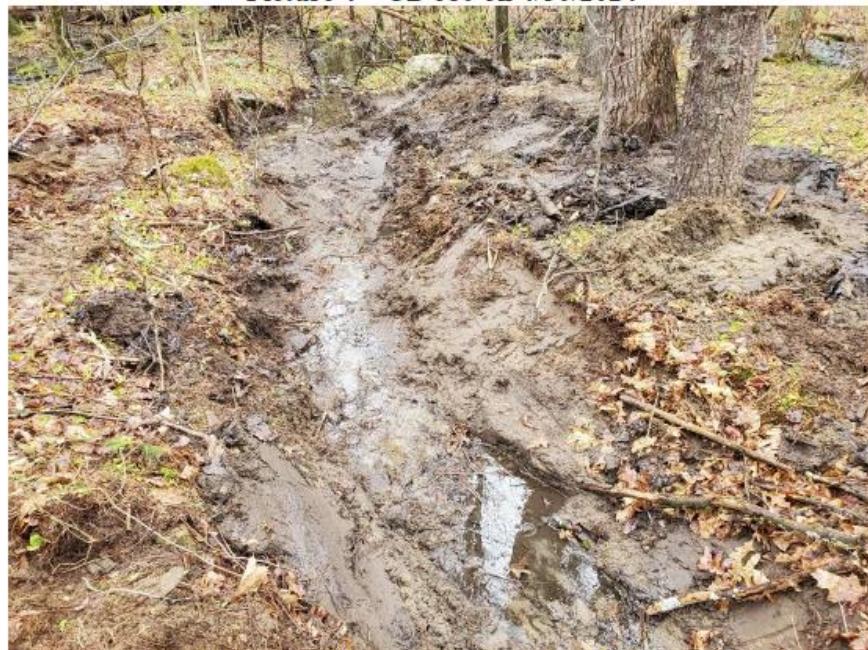
Picture 5 – Swale cleared with affected material placed on right (5/1/2024)

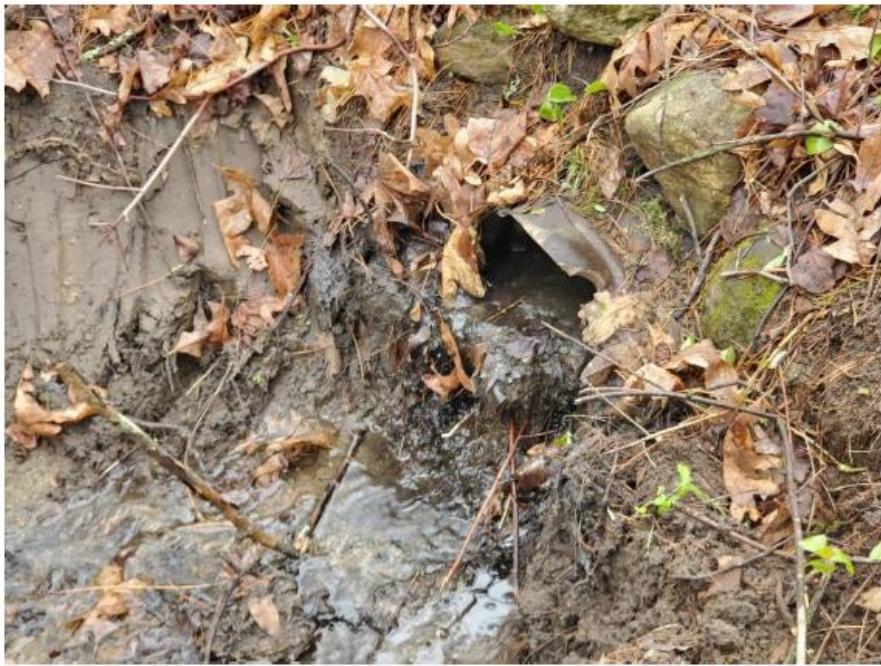
Picture 6 – Zoomed in photo of outfall 5/1/2024
