Illicit Discharge Detection and Elimination (IDDE) Plan

TOWN OF WINDHAM, NEW HAMPSHIRE

Permit Year 7

EPA NPDES Permit Number NHR041000

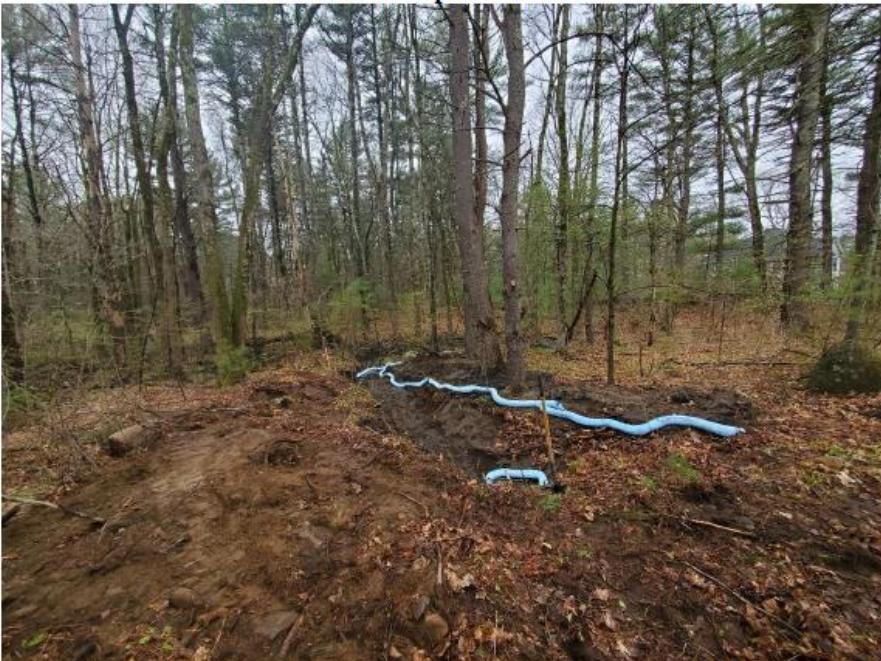
Picture 7 – Scene after Boom was placed 5/1/2024

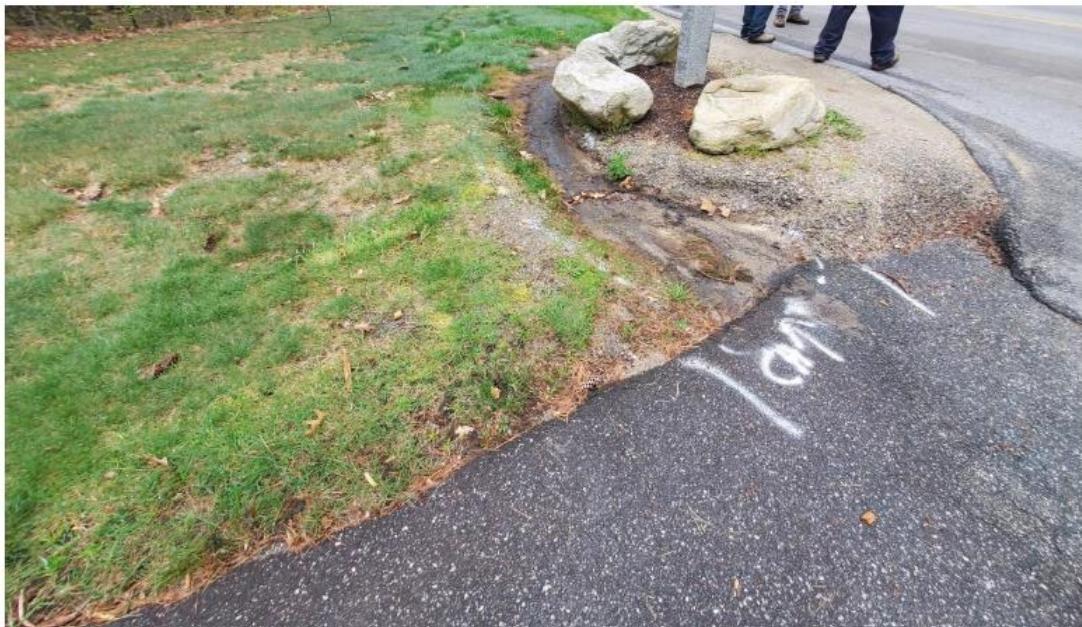
Picture 8 – Additional material caused by runoff from road 5/1/2024

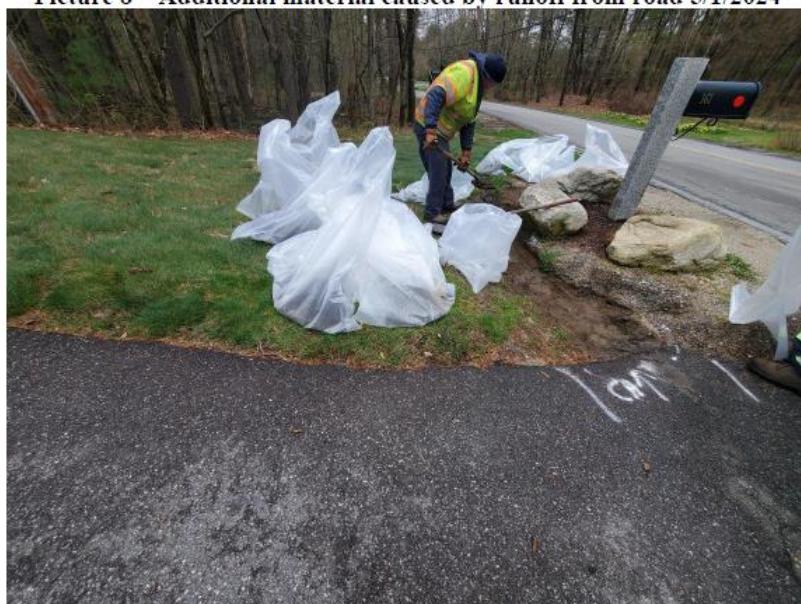
Picture 9 – Affected material being removed by Clean Harbors 5/1/2024

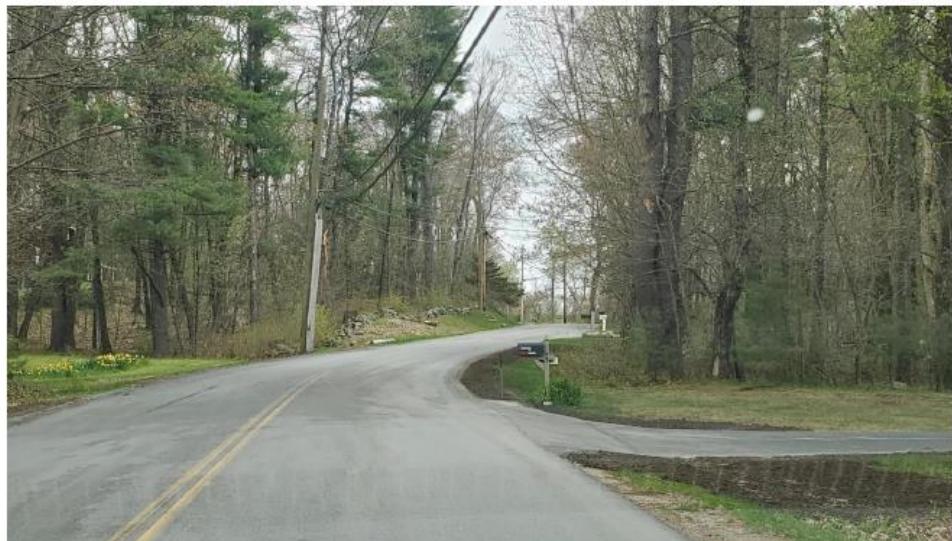
Picture 11 – Backfill
